TO: Jennifer Fitch, PE Project Manager Vermont Agency of Transportation	DATE	PROJECT NO.
	11/10/2014	Brookfield BRF FLBR (2)

COPIES	NUMBER	DESCRIPTION	CODE
1		FRP Fabrication NCR 13 - Pontoon 5 Shifted Mold Insert	H

Brookfield BRF FLBR (2)

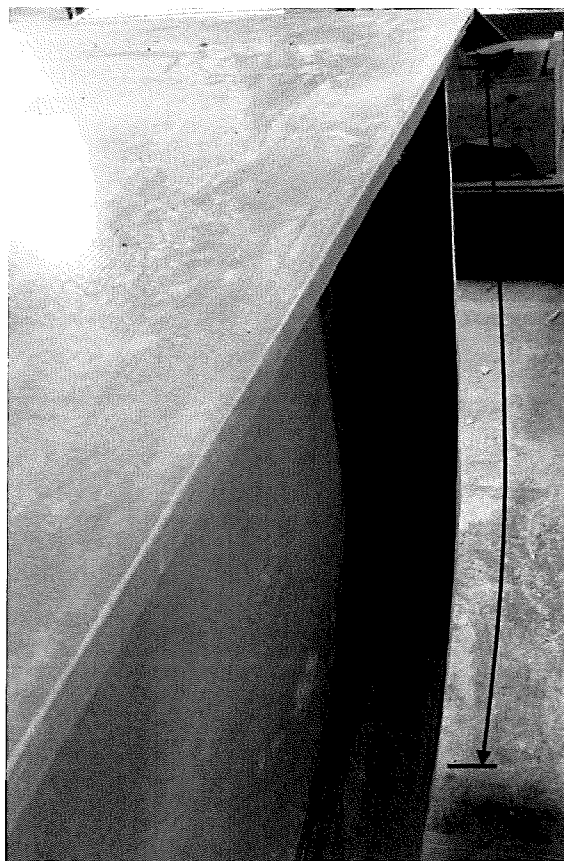
On October 31, Kenway identified that one end of Pontoon 5 was not square and too long due to the mold insert shifting during fabrication. The disparity was over a roughly 4 ft section starting with 1/2 in. excess at the 6 in. flange down to nothing at the bottom of the 2 ft radius. The end bulkheads were installed in the proper location.

The top plates were dry fit on Pontoon 10 to confirm the necessary cut line in the area where the hull mold insert shifted. After the excess material was removed from the hull, the cut surface was sealed with resin. A photo after the cut was made is shown below.
